OUTER SKIN PROTECTION OF COLUMBIUM THERMAL PROTECTION SYSTEM (TPS) PANELS

by
John D. Culp

MCDONNELL DOUGLAS ASTRONAUTICS COMPANY

Contract NAS3-15546

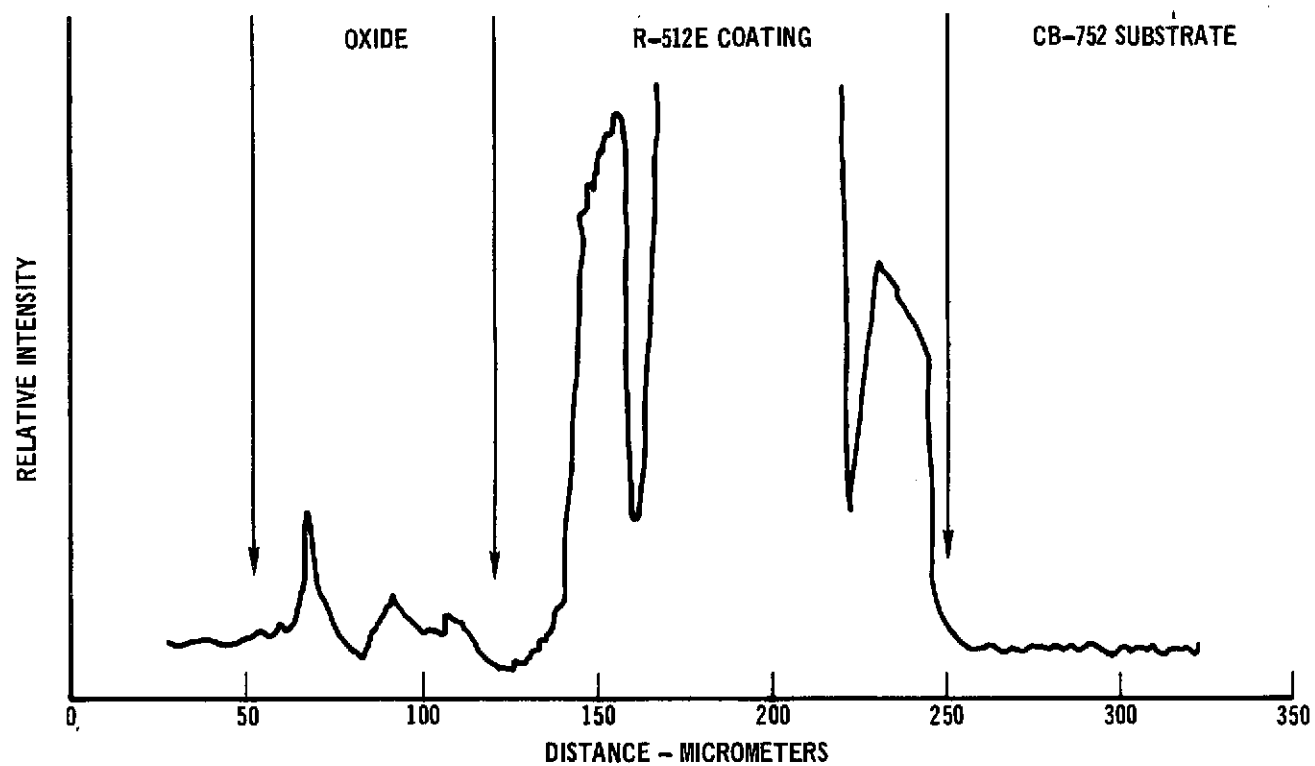
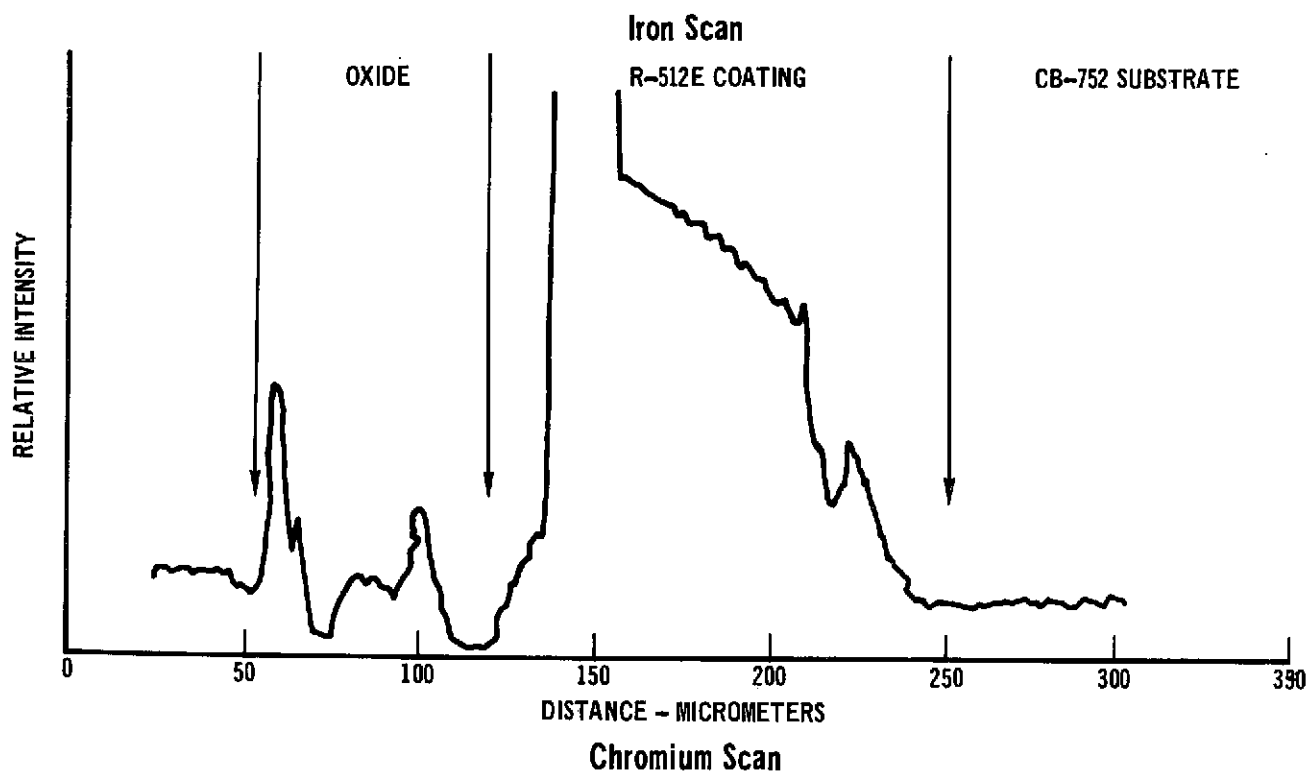
FIGURE 47 ELECTRON MICROPROBE SCANS OF CB-752 BASELINE MATERIAL
WITH THE R-512E COATING AFTER 100 REENTRY CYCLES
(TASK I EXPERIMENT)

Qualitative electron microprobe scans were made on typical 100 profile exposure cycle specimens for the first two program tasks. The results achieved are presented in figures 45 through 49. The most significant findings were the presence of a sharp interface between the B-1 cladding and the substrate and the absence of cladding alloy constituents migrating into the FS-85 core. This was a positive indication that titanium or aluminum was not diffusing into the FS-85 core to impair the mechanical properties (particularly creep strength) after long exposure times. The remaining scans indicated that the coatings were acting in a normal and predictable way, since the results obtained were similar to those found by HiTemCo, (reference 8).

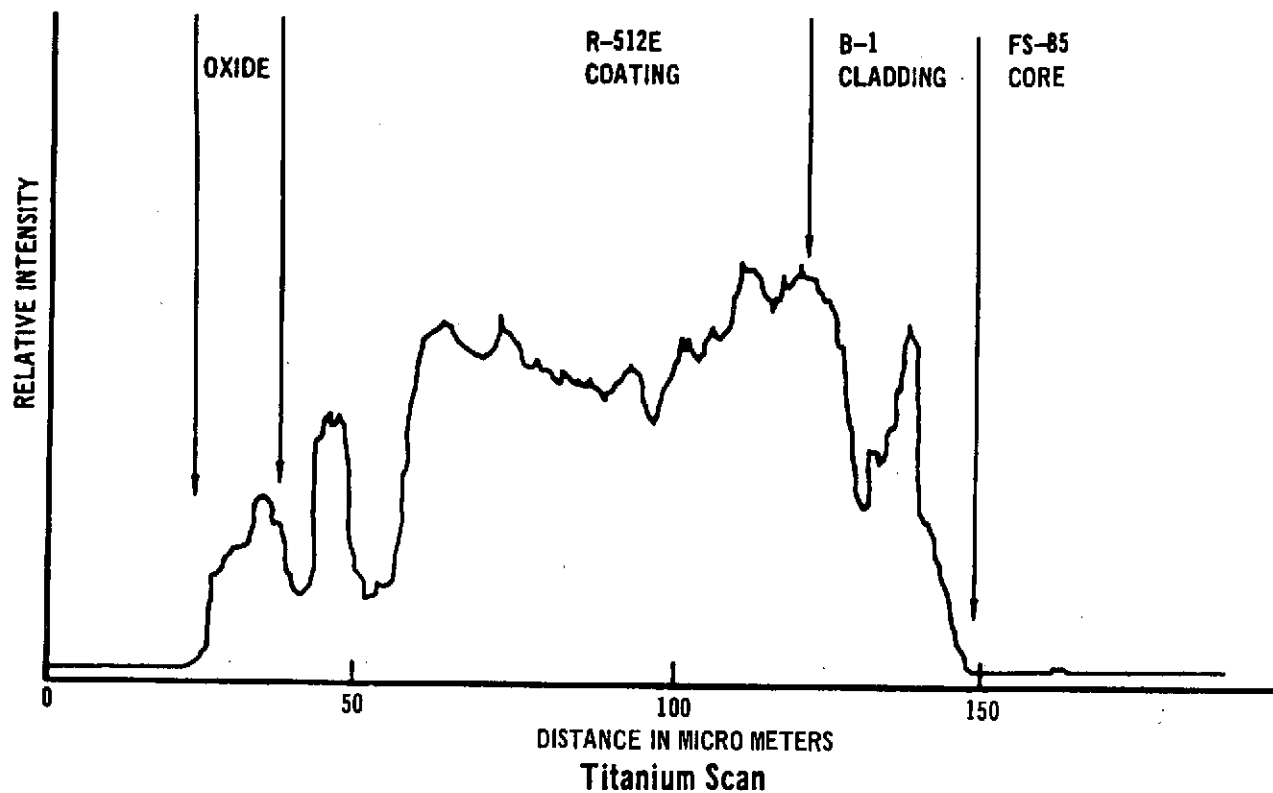
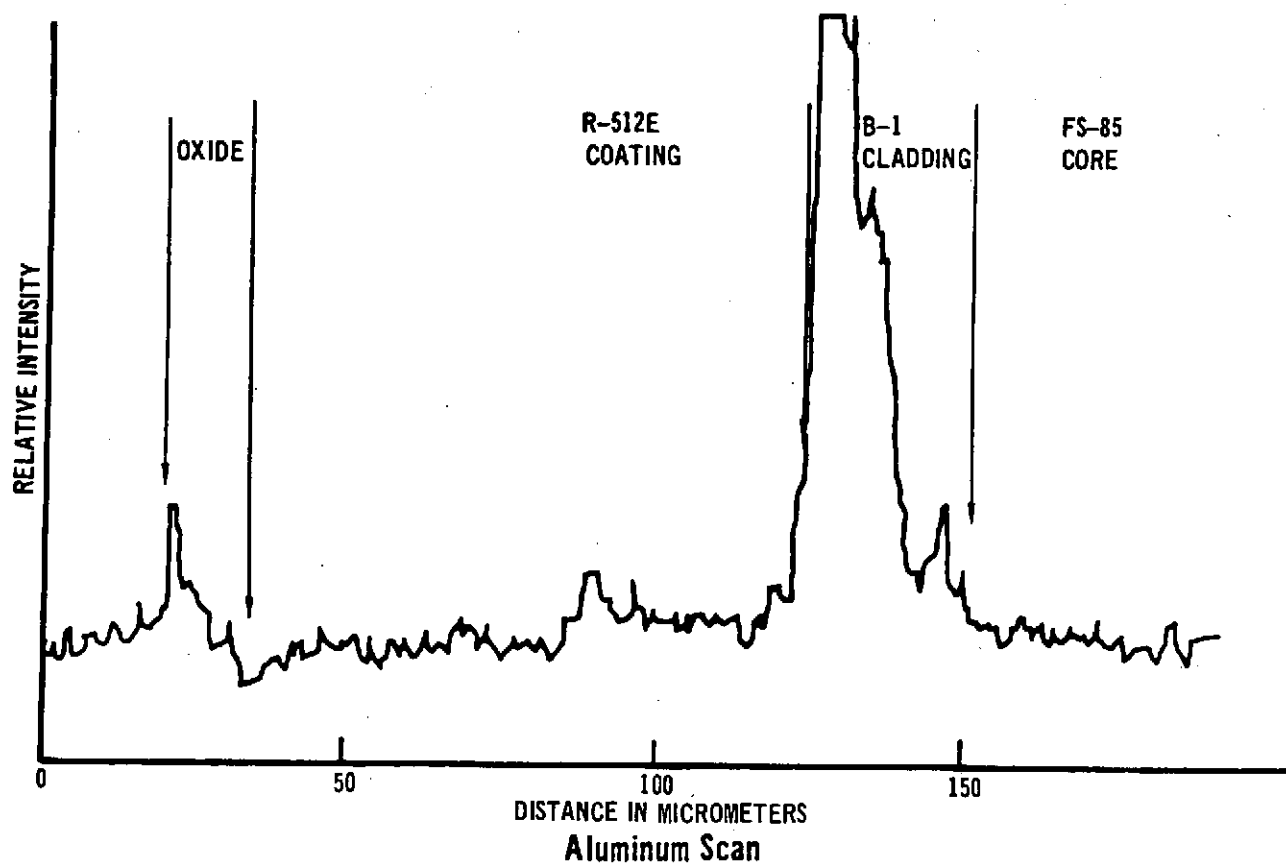
FIGURE 48 ELECTRON MICROPROBE SCANS OF B-1 CLAD FS-85 WITH THE R-512E COATING AFTER 100 REENTRY PROFILE CYCLES

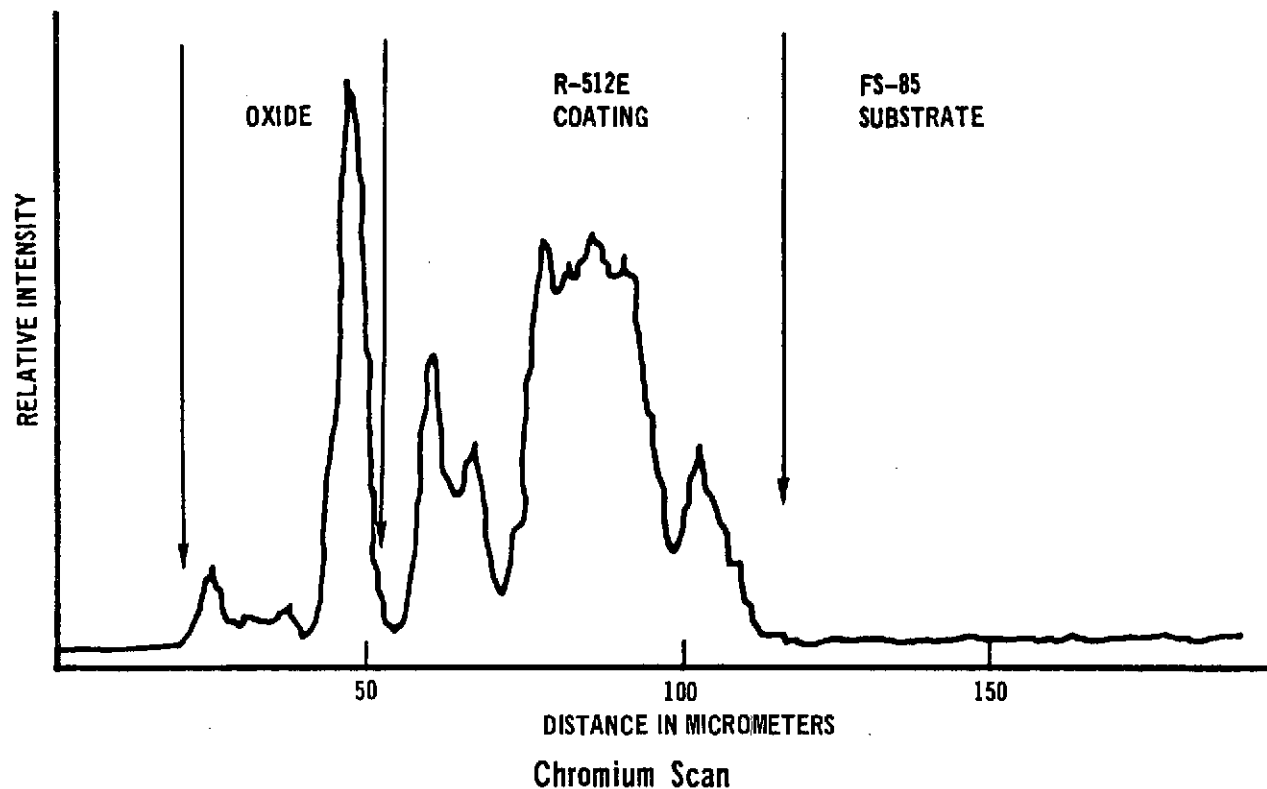
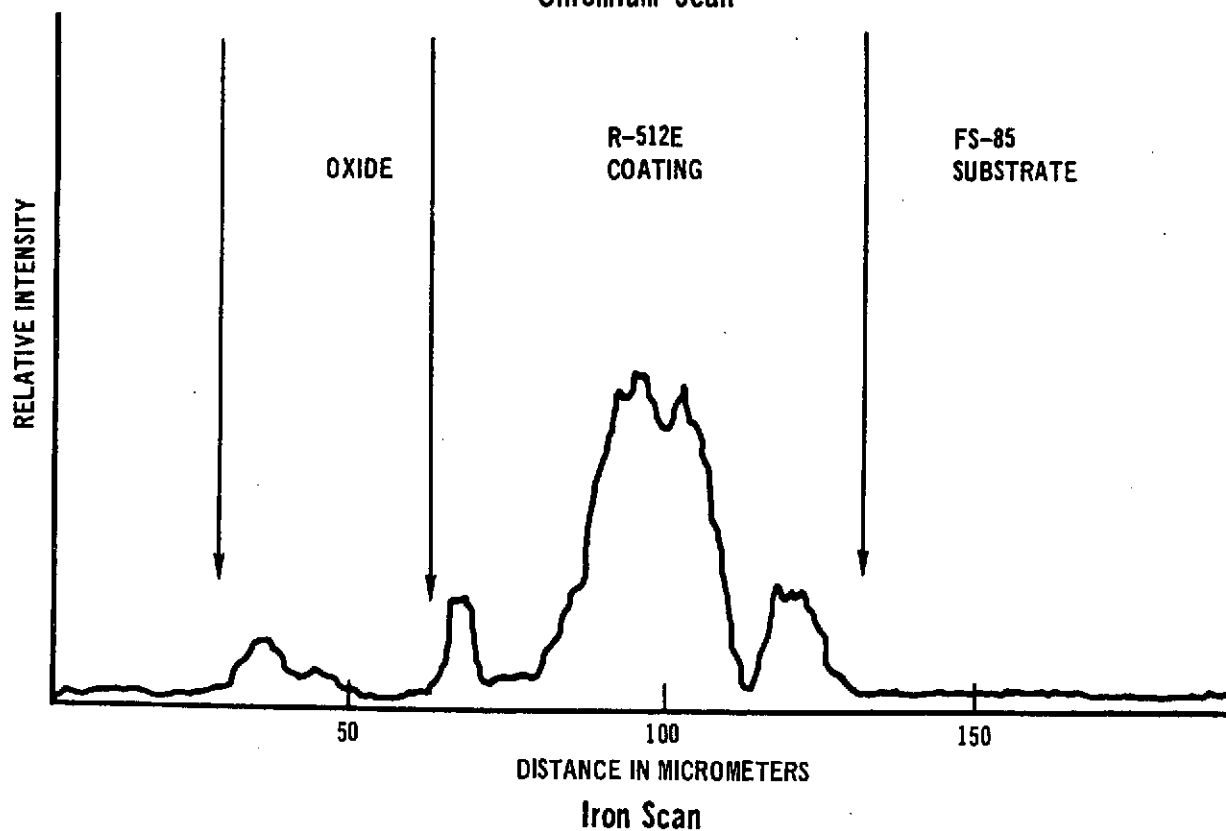
FIGURE 49 ELECTRON MICROPROBE SCANS OF R-512E COATED FS-85 WITHOUT CLADDING AFTER 100 REENTRY PROFILE CYCLES

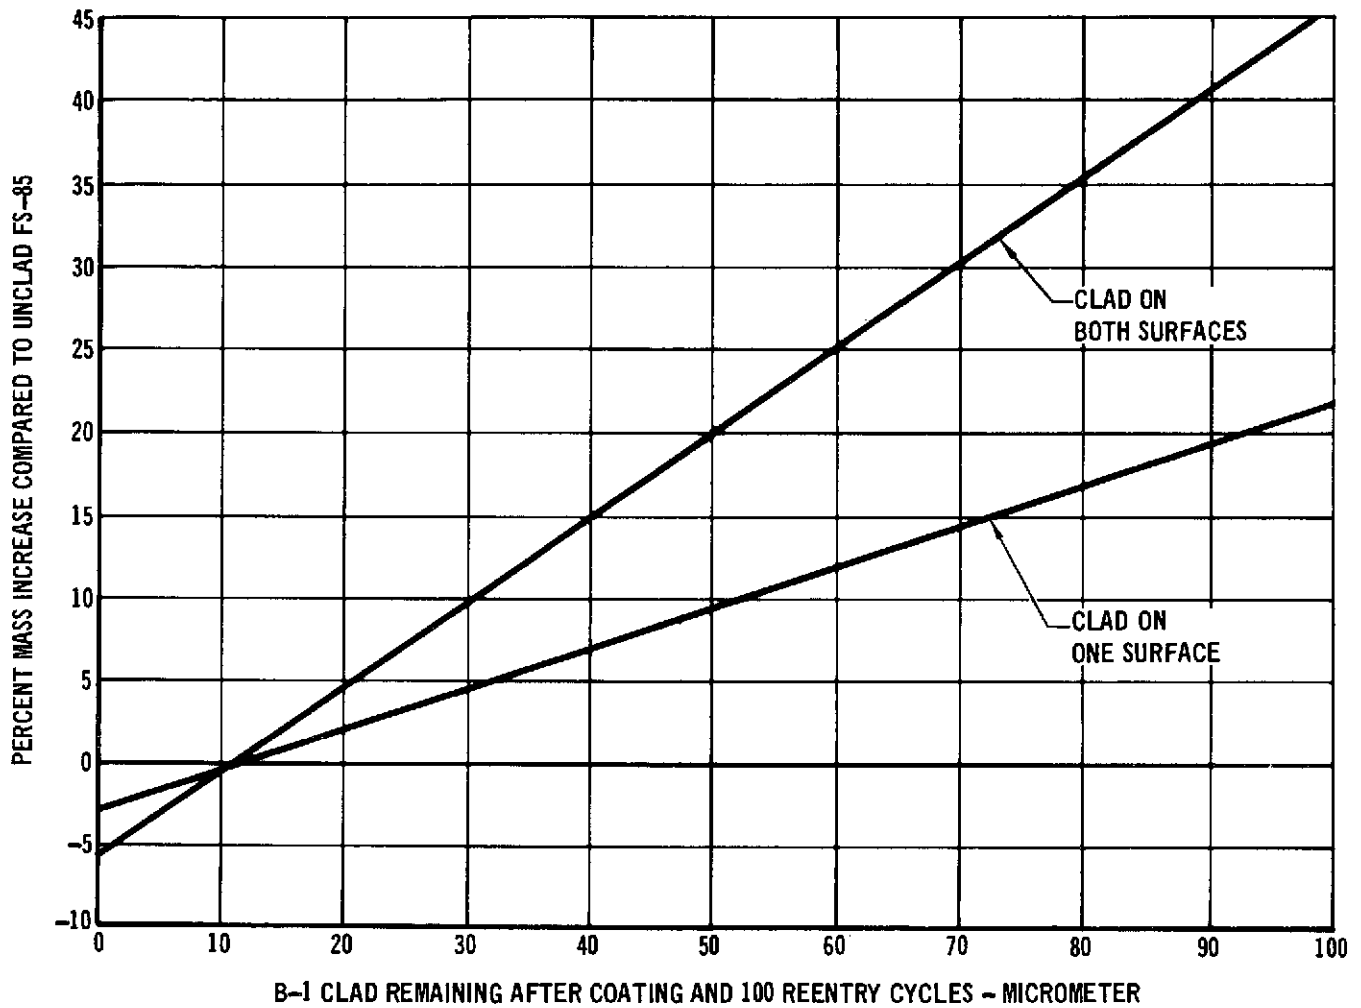
FIGURE 50 EFFECT OF B-1 CLADDING ON MASS OF FS-85 SHEET

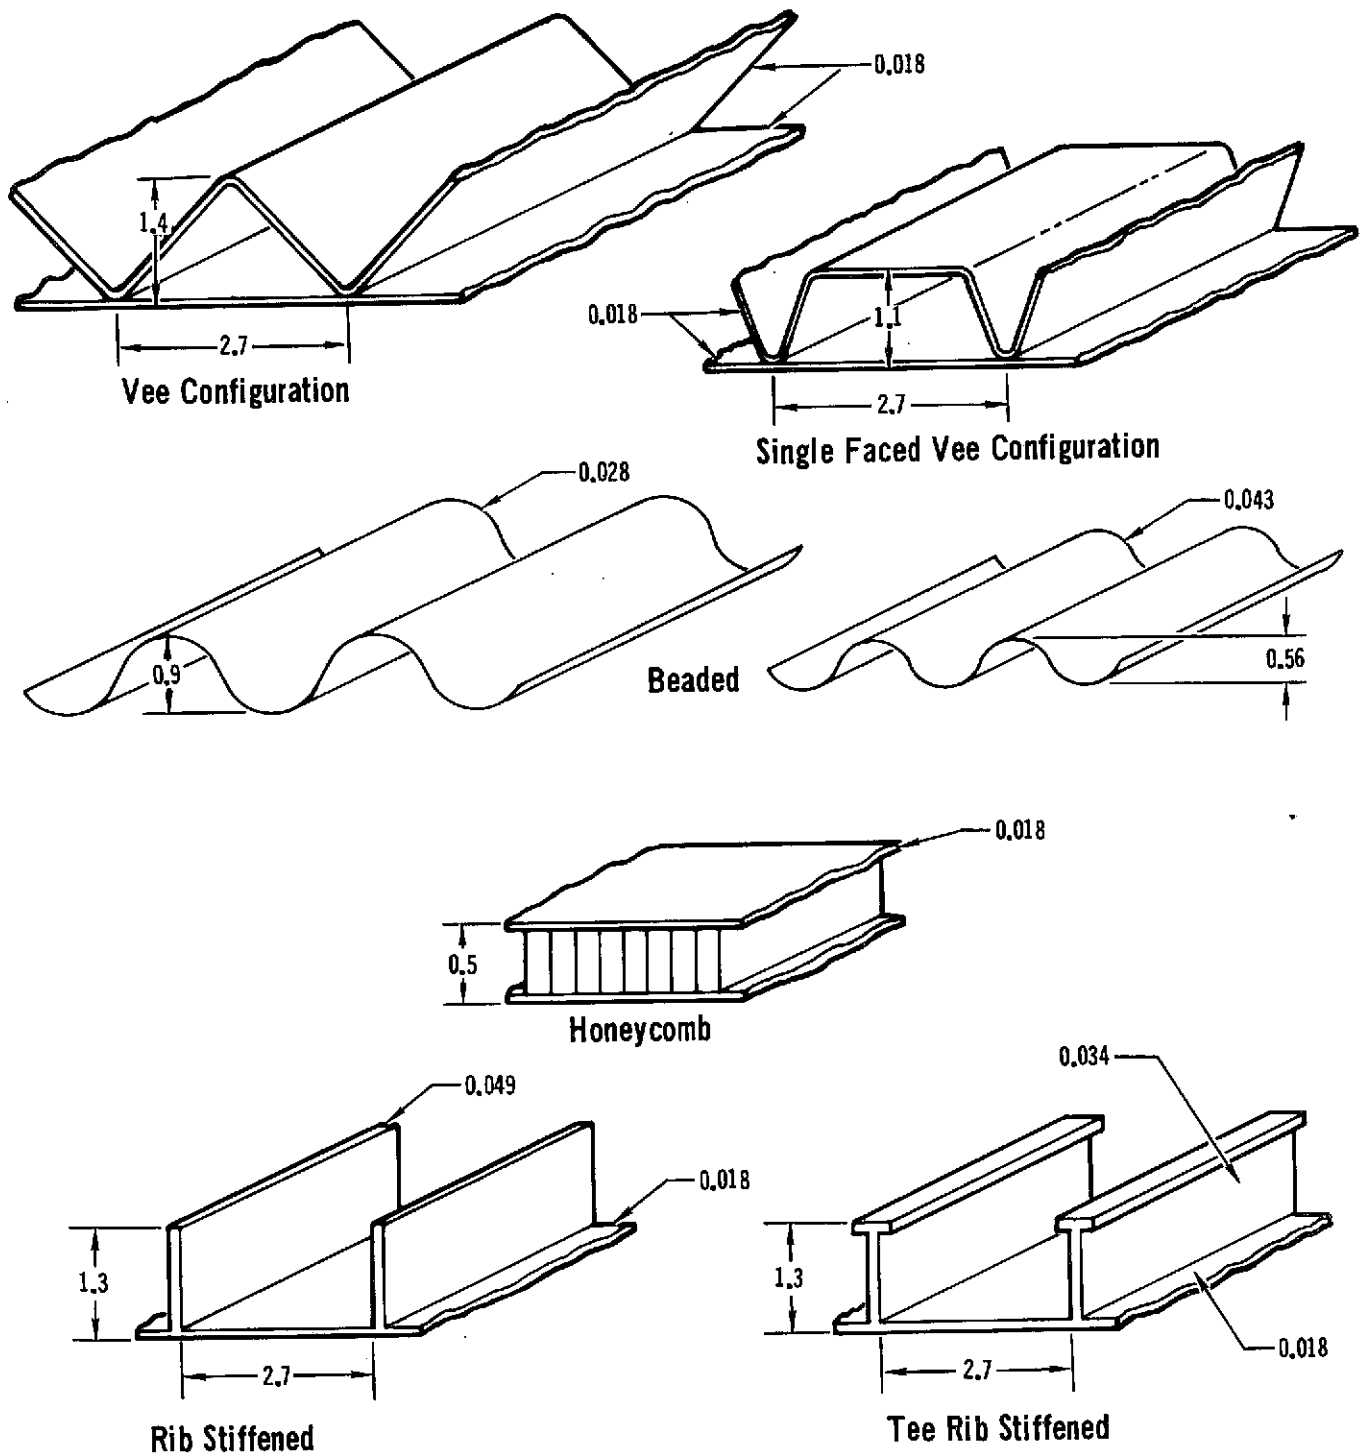
FIGURE 51 CURRENT COLUMBIUM DESIGN APPROACHES
